SERVICE REPRESENTATIVE'S REPORT

PRATT AND WHITNEY AIRCRAFT
EAST HARTFORD 8, CONNECTICUT

1. Convair COIN Incident

1. Convair COIN Program

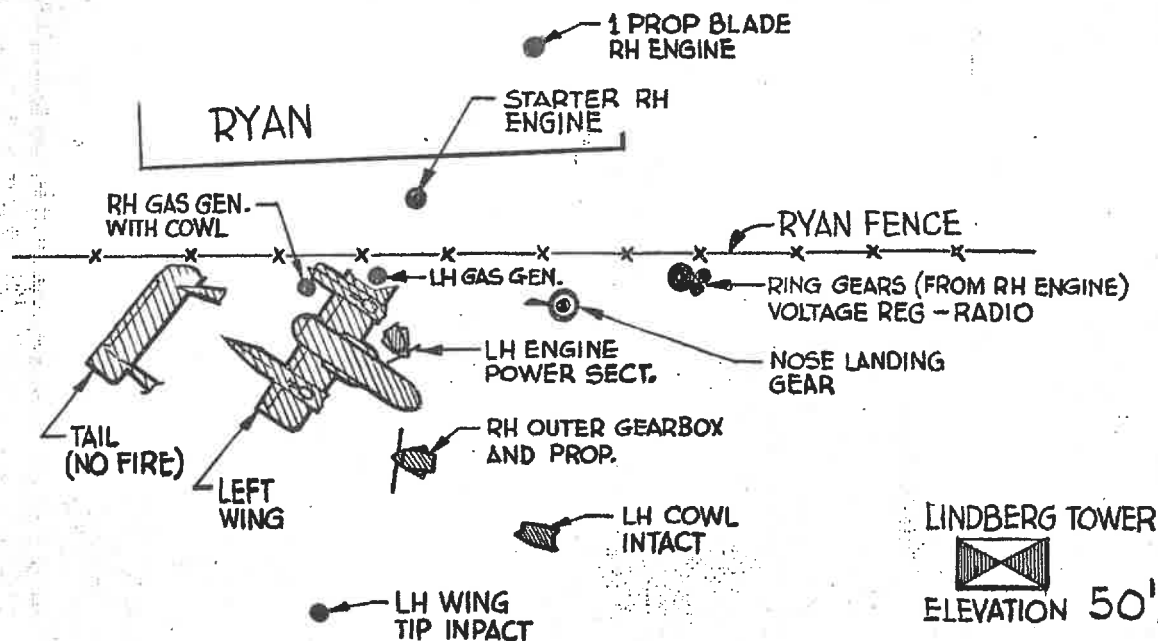
CONSTRUCTION AREA

RUNWAY 27

The photographs and sketch generally describe the crash area as to location of the debris. The left engine(feathered on impact)broke free from its nacelle and was found in front of the right nacelle. The power section separated completely, and intact, from the gas generator and was found adjacent to the latter. The propellor hub was intact and attached to the prop shaft. The prop blades were feathered. The prop hub was found in relatively good shape.

The right engine gas generator remained generally in its nacelle. The outer reduction gearbox separated at the mounting flange and came to rest forward of the left nacelle area. The first stage reduction ring gears and torquemeter gearing were thrown into the area where the aircraft nose ballast and equipment were found. The propellor hub was intact and attached to the prop shaft. One blade remained in the hub and was in fine pitch. Of the other two blades, one was found in the wreckage and the other landed on the roof of part of the Ryan plant some 100 yards distant.
